PROJECT BRIEF

Lower Canyon Creek Restoration

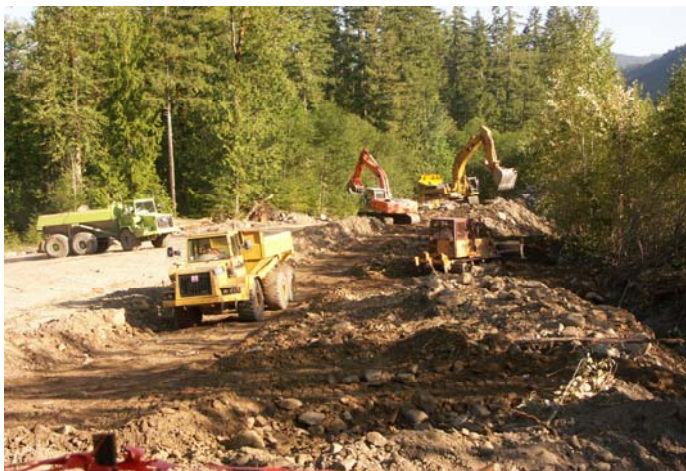
July 2009 Levee removal underway

During construction, the downstream 520 feet of levee were removed and the new south end of the levee re-established. The levee fill was used to re-shape the removal area and to fill two swales that had directed flow to the Mt. Baker Highway. An old access road was also blocked; combined these will encourage flow to spread out through the mature forest and mitigate effects of the levee removal. The large boulders that had been placed in 1994 to constrict the floodplain were also removed.

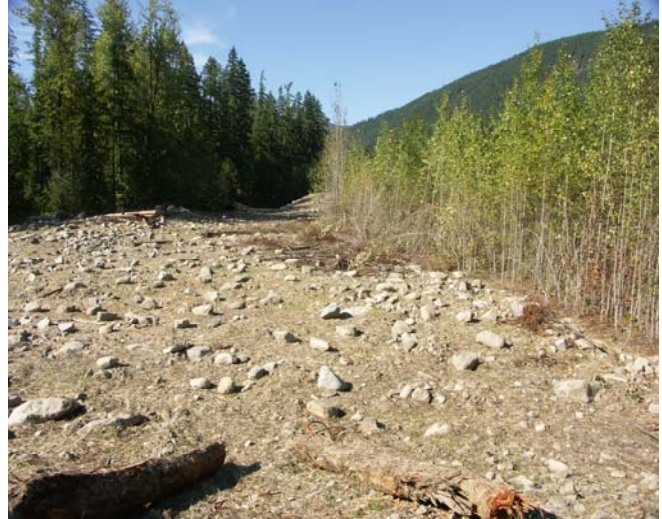
July 2009 Levee removal complete and site reshaped

These actions will also provide an outlet should the levee breach upstream allowing water to flow into the low area to the west of the levee. Previously flow would have been trapped and had greater potential to overtop the banks and head toward the highway.
